# Delamination Issues with Laminated Glass – Causes and Prevention

Mr. Phillip Davies, Du Pont (Australia) Limited  
Mr. Robert Cadwallader, E.I. duPont de Nemours & Co. Inc.

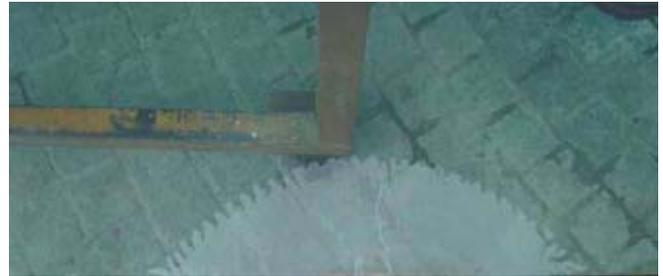
Fig 1

'Sunburst' delaminations (see Figure 1) in some projects have undoubtedly caused concern in the glazing industry. This type of delamination is generally the result of poor manufacturing processes, which impart stresses at locations at the edges of laminated glass, often combined with thinning of the PVB. Optical distortion is also normally evident at these locations. The most common cause of this type of localized delamination is the use of clamping devices on the edges of laminated tempered glass during the autoclaving of the laminated glass. While the quality of the glass may appear to be satisfactory at time of dispatch of the glass from the factory gradual release over time of the stresses imparted to the glass at the locations that were clamped may result in 'sunburst' delaminations.

A 'sunburst' delamination; cause – poor manufacturing processes

1. 'Sunburst delaminations' can be avoided by the use of good laminating practices and in the case of laminated heat treated glass by use of heat treated glass of a suitable quality for lamination. Mechanical force should not be employed to the edges of laminates during the autoclaving process.
2. There is a substantial difference in the edge stability performance of laminates containing B14 PVB interlayer and a now obsolete Type X PVB interlayer, both with exposed

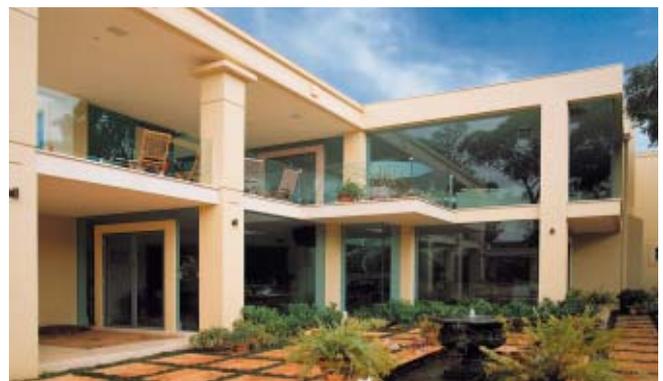
Fig 2

Five-year old residence in Melbourne exemplifies projects in which laminated glass containing B14 PVB have exhibited no edge delamination.

for aesthetics, safety, security, energy efficiency and sound reduction. Neither the silicone butt-joined edges or exposed edges of the laminated glass exhibit any edge delamination.

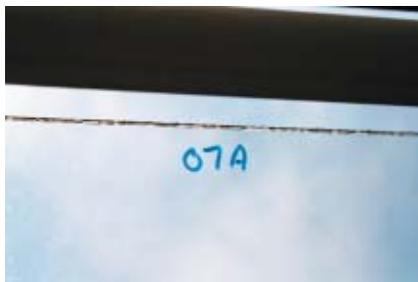
Fig 5  
Open edge of a typical B14 laminate after 54 months of Florida Exposure

Figure 5 shows a picture representative of the exposed edges of laminates containing B14 interlayer after 54 months of Florida exposure while Figure 6 shows the exposed edge of a laminate containing Type X interlayer after the same 54 months of Florida exposure.

It is believed that the minor degree of edge delamination seen in the Florida studies with B14 is the result of thinning of the PVB at the very edge of the laminate caused by a small amount of PVB flow at the edges during the autoclave process. This mechanism has been demonstrated with laminated glass containing holes for point fixing. As in the case of holes in laminated glass, it is believed that improvements to the lamination process can prevent this small amount of PVB flow at laminate edges although this has yet to be demonstrated.

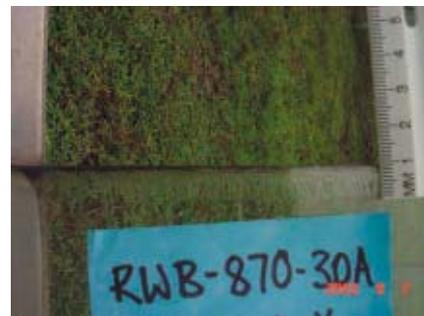
Fig 6  
Open edge of a Type X laminate after 54 months of Florida exposure

A considerable difference can be seen in the edge stability performance of exposed edges of laminates containing B14 interlayer versus those containing Type X interlayer.

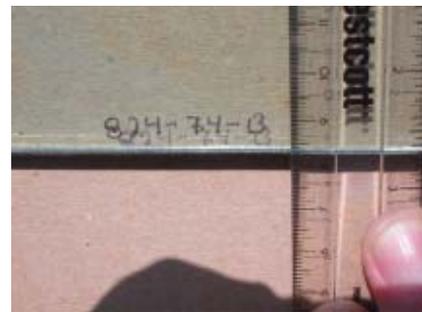
Fig 11

Figure 11 shows a picture of the edge of laminate 824-74-13 that is indicative of all thirteen laminates. The SGP along the laminate edge forms an opaque white polymeric residue approximately 1 mm in depth. In some instances this residue has turned green due to the mold from the high humidity

SGP laminate exposed edge after 61 months of Florida exposure – no edge defects
