Delamination Issues with Laminated Glass – Causes and Prevention

Mr. Phillip Davies, Du Pont (Australia) Limited
Mr. Robert Cadwallader, E.I. duPont de Nemours & Co. Inc.

Abstract

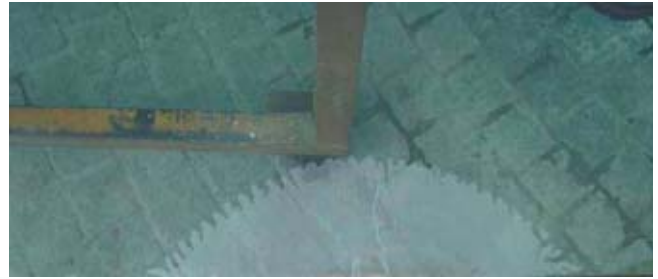
Fig 1

'Sunburst' delaminations (see Figure 1) in some projects have undoubtedly caused concern in the glazing industry. This type of delamination is generally the result of poor manufacturing processes, which impart stresses at locations at the edges of laminated glass, often combined with thinning of the PVB. Optical distortion is also normally evident at these locations. The most common cause of this type of localized delamination is the use of clamping devices on the edges of laminated tempered glass during the autoclaving of the laminated glass. While the quality of the glass may appear to be satisfactory at time of dispatch of the glass from the factory gradual release over time of the stresses imparted to the glass at the locations that were clamped may result in 'sunburst' delaminations.

A 'sunburst' delamination; cause – poor manufacturing processes

1. 'Sunburst delaminations' can be avoided by the use of good laminating practices and in the case of laminated heat treated glass by use of heat treated glass of a suitable quality for lamination. Mechanical force should not be employed to the edges of laminates during the autoclaving process.
2. There is a substantial difference in the edge stability performance of laminates containing B14 PVB interlayer and a now obsolete Type X PVB interlayer, both with exposed

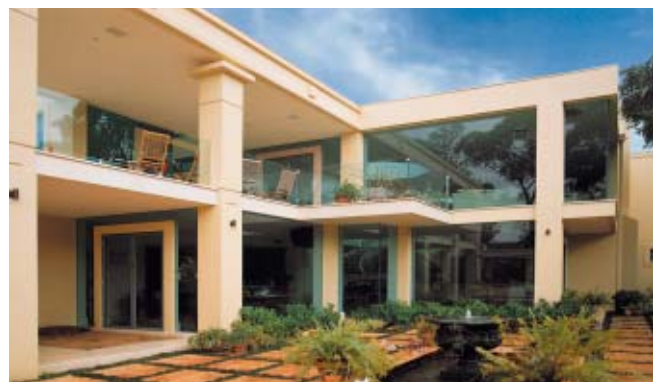
Fig 2

Five-year old residence in Melbourne exemplifies projects in which laminated glass containing B14 PVB have exhibited no edge delamination.

for aesthetics, safety, security, energy efficiency and sound reduction. Neither the silicone butt-joined edges or exposed edges of the laminated glass exhibit any edge delamination.

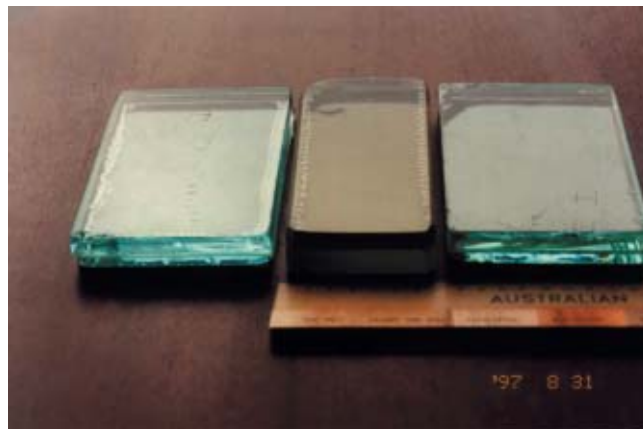
Fig 3

This icon was opened in 1973. By 1978 it was noticed by some observers that the edges of the butt-joined laminated glass walls had developed up to around 12 mm (~ 1/2 inch) of delamination along the edges of the glass. An article in the July 1984 edition of Glass Digest magazine entitled "The Do's and Don'ts of Laminated Glass" attributed this delamination to

the acetoxy acid cure silicone used. However a study conducted by DuPont at the end of 1980 had reached a different conclusion. In the DuPont study samples of laminated glass having the same construction as the Opera House glass were produced; some samples contained the same Type X PVB interlayer used in the Opera House, while others contained B14 PVB interlayer. The acetoxy silicone sealant used in the Opera House was applied to some edges, while other edges were left bare. After exposure to humidity and temperature cycling the samples of laminated glass containing Type X interlayer exhibited delamination similar to that seen in the Opera House glass, both on edges with silicone and bare edges, while the samples containing the B14 PVB interlayer exhibited zero edge delamination. The samples used in this study have the same appearance today as in 1980 – see Figure 3.

A laminate from the Opera House is shown in the centre; on the left is the laboratory test sample containing the same Type X PVB interlayer as in the Opera House laminate; on the right is the laboratory test sample containing B14 PVB interlayer

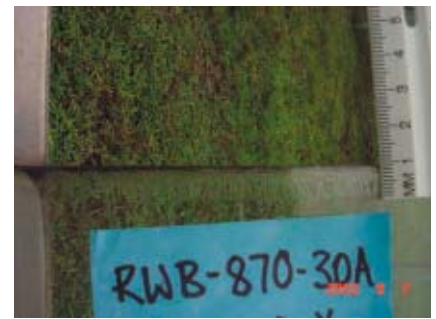
Fig 5
Open edge of a typical B14 laminate after 54 months of Florida Exposure

Figure 5 shows a picture representative of the exposed edges of laminates containing B14 interlayer after 54 months of Florida exposure while Figure 6 shows the exposed edge of a laminate containing Type X interlayer after the same 54 months of Florida exposure.

A considerable difference can be seen in the edge stability performance of exposed edges of laminates containing B14 interlayer versus those containing Type X interlayer.

It is believed that the minor degree of edge delamination seen in the Florida studies with B14 is the result of thinning of the PVB at the very edge of the laminate caused by a small amount of PVB flow at the edges during the autoclave process. This mechanism has been demonstrated with laminated glass containing holes for point fixing. As in the case of holes in laminated glass, it is believed that improvements to the lamination process can prevent this small amount of PVB flow at laminate edges although this has yet to be demonstrated.

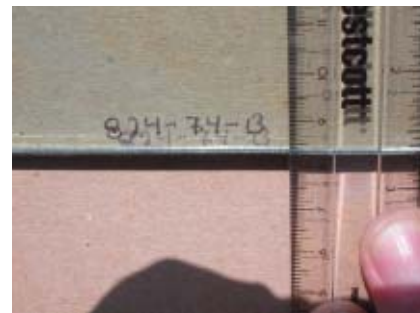
Fig 11

Thirteen 762 mm x 1194 mm (30" x 47") laminates with exposed edges were placed on exposure in September 1997. Inspection after 61 months of weathering has revealed no edge defects in any of the laminates (ESI of 0).

Figure 11 shows a picture of the edge of laminate 824-74-13 that is indicative of all thirteen laminates. The SGP along the laminate edge forms an opaque white polymeric residue approximately 1 mm in depth. In some instances this residue has turned green due to the mold from the high humidity

SGP laminate exposed edge after 61 months of Florida exposure – no edge defects
