# Delamination Issues with Laminated Glass – Causes and Prevention

Mr. Phillip Davies, Du Pont (Australia) Limited  
Mr. Robert Cadwallader, E.I. duPont de Nemours & Co. Inc.

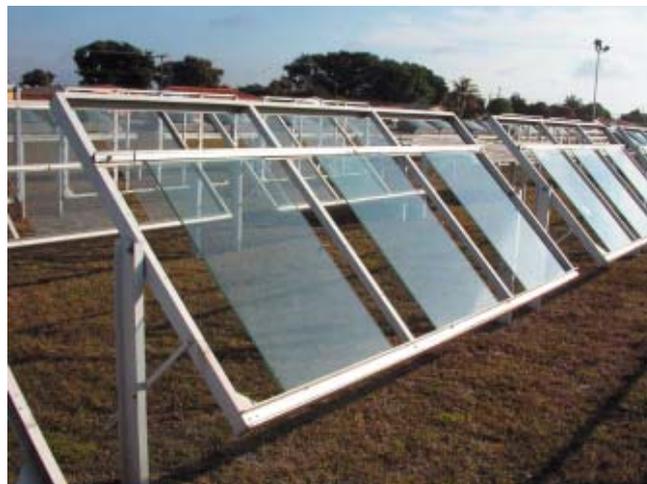
Fig 4

Samples of laminated glass at the DuPont Weathering Site, Hialeah Florida.

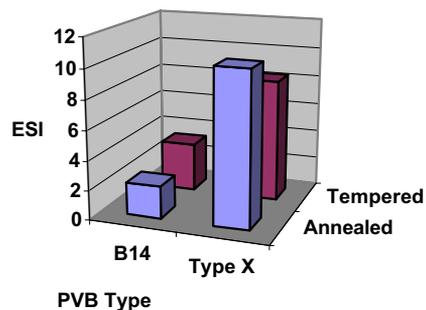
Fig 8  
ESI data by PVB and glass type

Table 3  
Summary of ESI data by PVB and glass type

A considerable difference can be seen in the edge stability performance of exposed edges of laminates containing B14 interlayer versus those containing Type X interlayer.

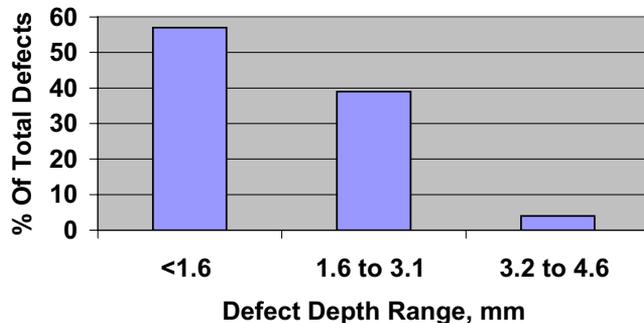
Fig 7

Figure 7 shows a plot of average defect depth for the annealed B14 laminates in Table 1 as a percentage of the total number of defects. 57% of the edge defects are less than 1.6 mm (1/16 inch) in depth, 39% of the edge defects are between 1.6 mm and 3.1 mm (1/8 inch) and 4% of the total exposed edge length had defects between 3.2 mm and 4.7 mm (3/16 inch) in depth.

Plot of defect depth for B14 annealed laminates after 54 months of Florida exposure

It is believed that the minor degree of edge delamination seen in the Florida studies with B14 is the result of thinning of the PVB at the very edge of the laminate caused by a small amount of PVB flow at the edges during the autoclave process. This mechanism has been demonstrated with laminated glass containing holes for point fixing. As in the case of holes in laminated glass, it is believed that improvements to the lamination process can prevent this small amount of PVB flow at laminate edges although this has yet to be demonstrated.

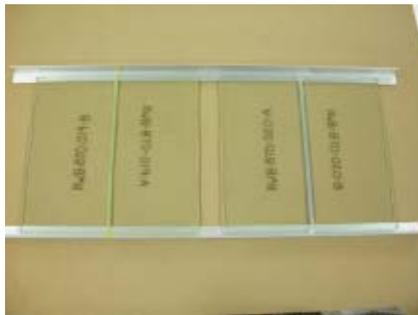
Fig 9  
Silicone butt-joined samples used for Florida edge stability study

sealant. After securing the butt-joined laminates to aluminum frames the samples were placed on exposure (see Figure 9). The laminates were placed on exposure in April 1998 and last inspected in August 2002 (4.3 years of natural weathering).

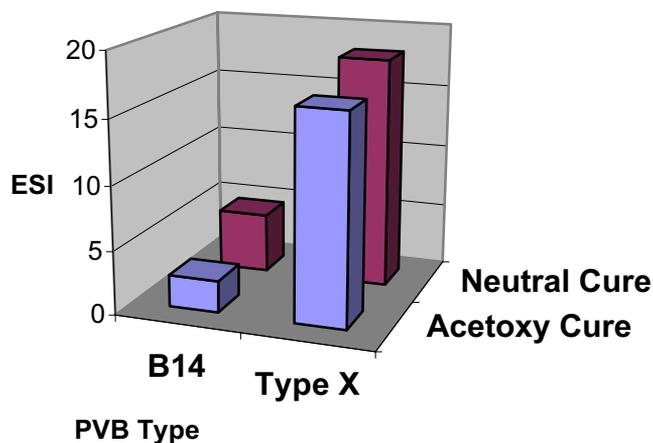
Fig 10

Table 4 and Figure 10 summarize the ESI results after 4.3 years of weathering. The following observations were made:

1. As with exposed edges there is a considerable difference between the results for laminates containing B14 interlayer and the now obsolete Type X interlayer.
2. There was not a great difference between the results with the two different silicone cure systems. The neutral cure silicone gave slightly higher ESI values than the acetoxy cure silicone with both interlayer types.
3. With the laminates containing B14 interlayer no defects were deeper than 4 mm.

ESI data by silicone type after 4.3 years of weathering
