Delamination Issues with Laminated Glass – Causes and Prevention

Mr. Phillip Davies, Du Pont (Australia) Limited
Mr. Robert Cadwallader, E.I. duPont de Nemours & Co. Inc.

Abstract

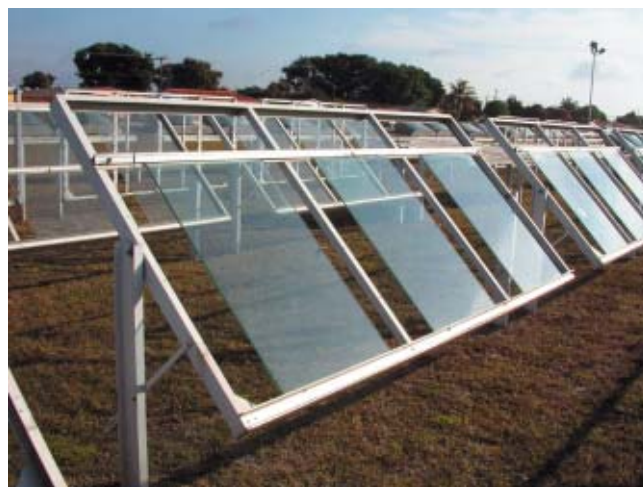
Fig 4

Samples of laminated glass at the DuPont Weathering Site, Hialeah Florida.

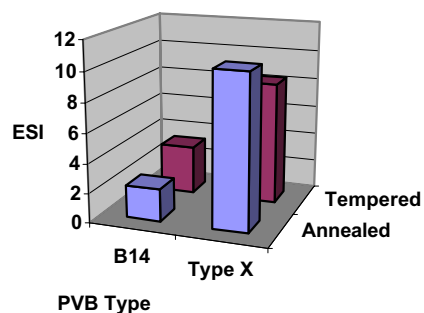
PVB Type	Data Type	Annealed	Tempered
B14	Samples	8	3
	Average	2.2	3.3
	Std Dev	1.2	1.9
Type X PVB	Samples	3	2
	Average	10.4	8.3
	Std Dev	2.6	1.0

Fig 8
ESI data by PVB and glass type

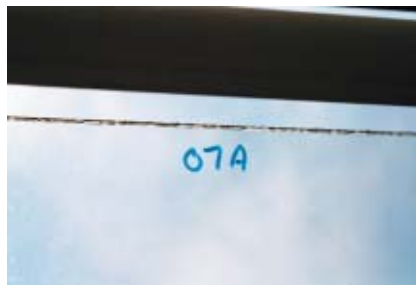
Figure 5 shows a picture representative of the exposed edges of laminates containing B14 interlayer after 54 months of Florida exposure while Figure 6 shows the exposed edge of a laminate containing Type X interlayer after the same 54 months of Florida exposure.

Fig 5
Open edge of a typical B14 laminate after 54 months of Florida Exposure

It is believed that the minor degree of edge delamination seen in the Florida studies with B14 is the result of thinning of the PVB at the very edge of the laminate caused by a small amount of PVB flow at the edges during the autoclave process. This mechanism has been demonstrated with laminated glass containing holes for point fixing. As in the case of holes in laminated glass, it is believed that improvements to the lamination process can prevent this small amount of PVB flow at laminate edges although this has yet to be demonstrated.

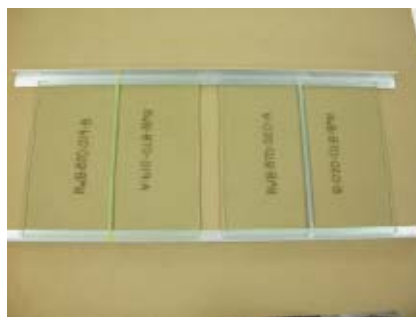
Fig 9
Silicone butt-joined samples used for Florida edge stability study

sealant. After securing the butt-joined laminates to aluminum frames the samples were placed on exposure (see Figure 9). The laminates were placed on exposure in April 1998 and last inspected in August 2002 (4.3 years of natural weathering).

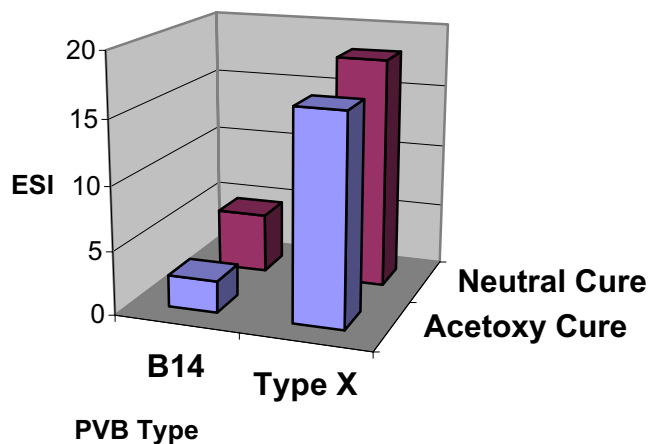
Fig 10

Table 4 and Figure 10 summarize the ESI results after 4.3 years of weathering. The following observations were made:

1. As with exposed edges there is a considerable difference between the results for laminates containing B14 interlayer and the now obsolete Type X interlayer.
2. There was not a great difference between the results with the two different silicone cure systems. The neutral cure silicone gave slightly higher ESI values than the acetoxy cure silicone with both interlayer types.
3. With the laminates containing B14 interlayer no defects were deeper than 4 mm.

ESI data by silicone type after 4.3 years of weathering
